# THE INSPECTION OF COLD WELDS IN ELECTROFUSION JOINTS

**Colin Bird**  
**Delphine Caravaca**  
**Angelique Raude**  
TWI  
Cambridge CB1 6AL, UK  
E-mail: [colin.bird@twi.co.uk](mailto:colin.bird@twi.co.uk)

This paper presents ultrasonic and thermal techniques for detecting and monitoring flaws in the weld. For post welding application a phased array ultrasonic technique is described that indicates flaws at the weld joint and the size of the heat affected zone as a record of the applied heat.

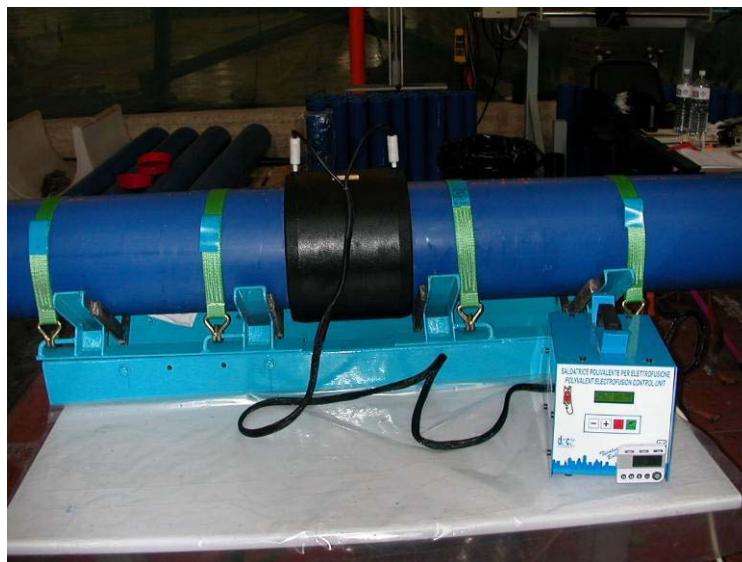
The application of the electrofusion process is shown in Figure 1. The pipes are inserted into the coupler and an electric current is passed through a heating element in the coupler, causing the plastic of the pipe and coupler to melt and fuse.

Figure 1. Electrofusion equipment and weld production

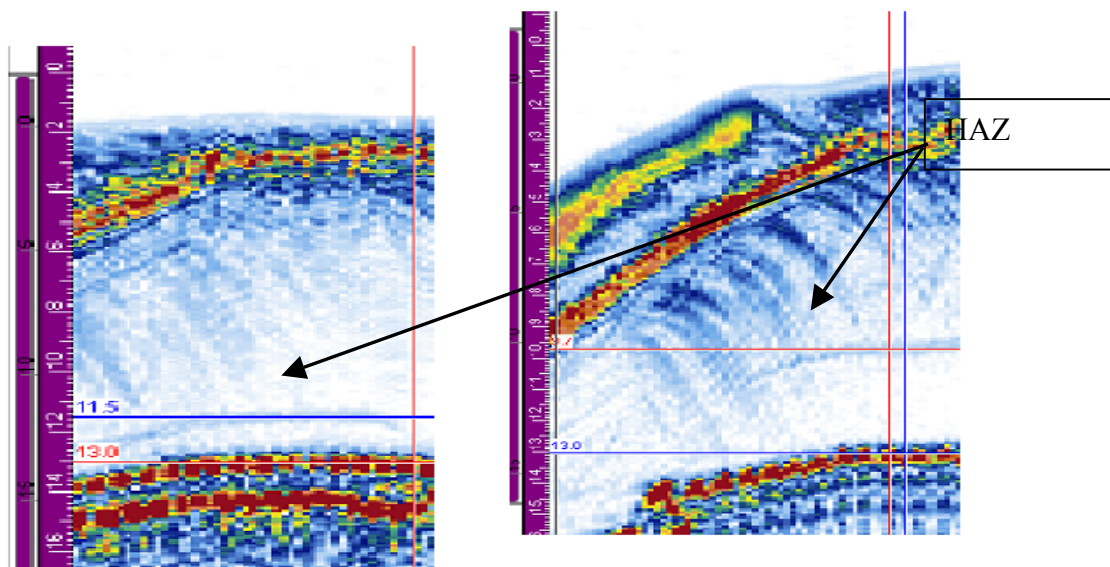
Figure 7 shows images of a correctly heated joint and a joint with insufficient heating. The images show the positions of the HAZ and the closer proximity of the HAZ to the wires for the insufficient heat input joint.

Figure 7. Comparison of welds with full and short heating cycles showing reduced HAZ.

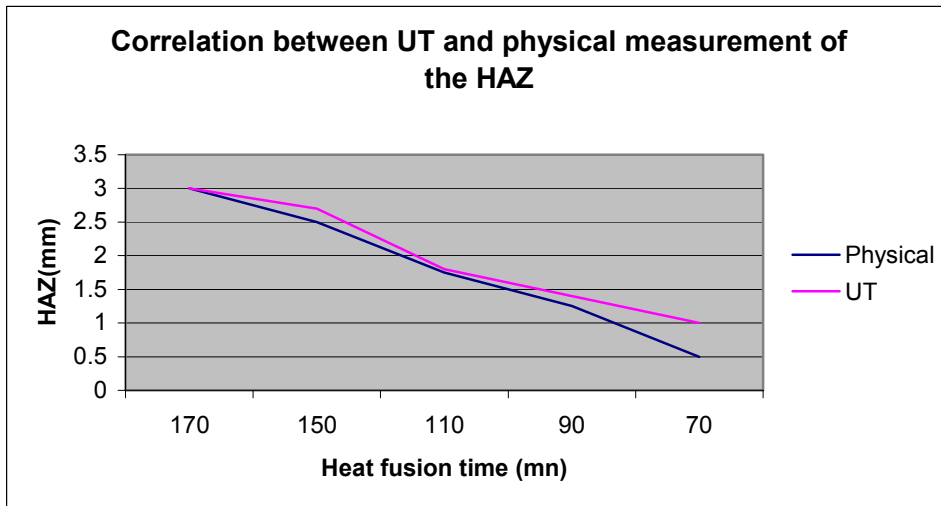
A correlation has been established between the physical measurement of the HAZ and the results obtain ultrasonically. These results are shown on the following Figure 8

This chart shows good correlation between the two results, the phased array inspection method providing an accurate and reliable measurement of the HAZ position and diagnosis of an incorrect heating cycle.

Figure 8: Correlation between the physical measurement of the HAZ and the value obtain with the phased array ultrasonic inspection.

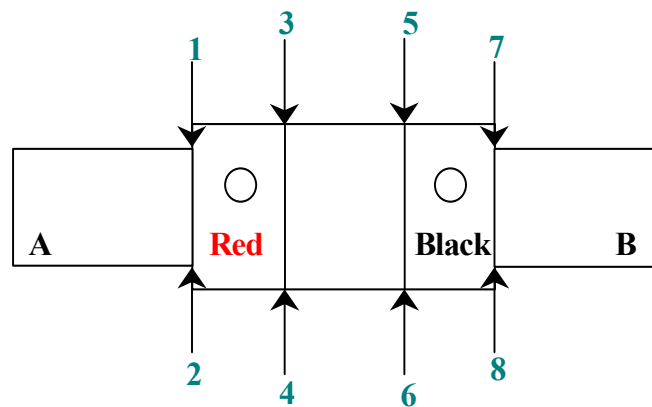
As introduced the project developed a thermal inspection system which place thermocouples onto the joint and measured the temperature change with respect to time during the welding stage and during reheat. Figure 8 shows the location of the thermocouples. This method can easily monitor and provide a permanent record that the correct heating cycle has been applied and provides evidence of any heating cycle anomalies.

Figure 8. Positioning of thermocouples on coupler

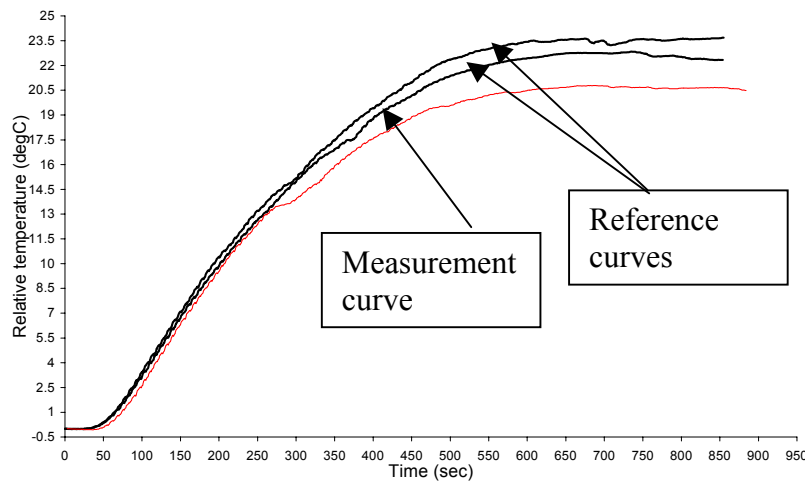
Figure 10. Thermal inspection results comparing fully fused full penetration reference joint and a joint with a pipe end which has not been scraped

Figures 9 and 10 provide examples of the thermal measurements. In both cases the black lines represent the thermal history of fully fused good joints and the red line shows the time history of a faulty joint. In both cases the temperature curve of the faulty joint was lower than that of the reference good joints. More trials are required to determine the error bands of the thermal history before flaw detection claims are made.

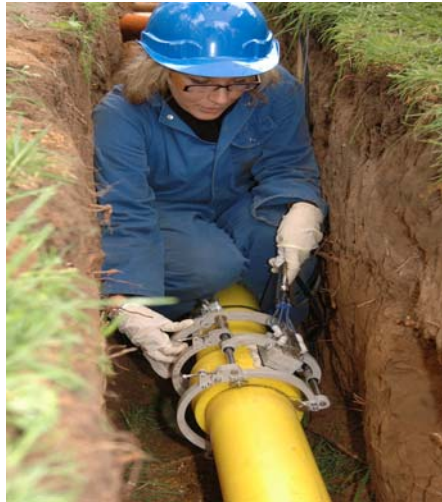
The system was demonstrated both at TWI and at Italgas in Italy. Figure 11 shows the equipment performing an inspection of a new 125mm gas pipe at TWI. The prototype demonstrated at Italgas proved to be easily deployed under site conditions with effective defect detection capability for the majority of defects. The existing ultrasonic techniques were not as effective for detection of lack of pipe scraping but the thermal inspection showed some difference between the scraped and un-scraped pipes as shown in Figure 10. More trials are required with the thermal inspection system before a conclusion is reached about its defect detection reliability. At present it is not clear whether un-scraped pipes fail in service. Using a pressure tests this defect has not shown reduced strength in the whole joint. Crush tests however show reduced mechanical strength.

Figure 11 Prototype of ultrasonic inspection manipulator operated in field conditions at TWI.
