DEVELOPMENT AND ASSESSMENT OF A PHASED ARRAY ULTRASONIC INSPECTION SYSTEM FOR POLYETHYLENE PIPE JOINTS

Mike Troughton, Malcolm Spicer and Fredrik Hagglund, TWI Ltd, Cambridge, UK

Abstract

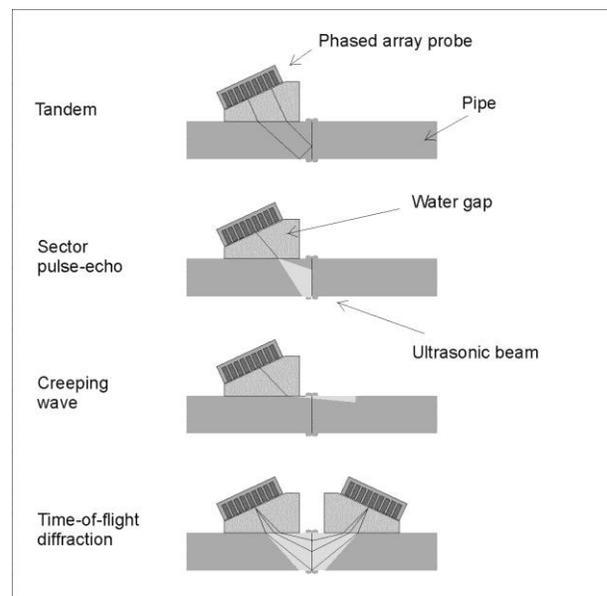
Figure 1. Inspection techniques used for BF joints.

Butt fusion and electrofusion joints require different inspection techniques. In BF joints the joint interface is perpendicular to the surface of the pipe and requires the use of angled ultrasound beams to detect any flaws that may be present at the interface. In order to obtain full wall-thickness coverage of the joint area, four different techniques were used (Figure 1): tandem, creeping wave, sector pulse-echo and time-of-flight diffraction (TOFD).

The tandem technique uses one half of the phased array elements in the probe for transmitting the ultrasound and the other half for receiving. The technique is good for detecting planar flaws; however, the coverage is restricted to an area approximately between the mid-wall thickness and the inner surface.

The sector pulse-echo technique uses all of the elements in the array to create an aperture, sweeping the

beam over a range of angles. This technique gives an overview of the joint and covers most of the fusion zone except for a few millimeters (tenths of an inch) close to the outer surface of the pipe.

The creeping wave technique only covers the region close to the outer surface of the pipe, which is the part not covered by the first two techniques. The technique uses a high-angle sector scan, producing compression waves propagating immediately beneath the inspection surface, to detect surface-breaking and near-surface defects.

The TOFD technique covers the entire fusion zone and uses forward diffraction to detect vertical flaws. The TOFD configuration used was a pitch-catch technique using two sector scans, where both transducers use a large aperture to transmit and receive beams covering the entire joint.

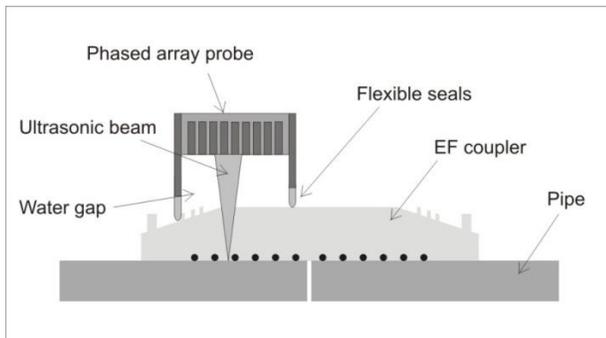
Figure 2. Inspection technique used for EF joints.

In EF joints, the fusion interface is parallel to the surface of the pipe and a normal (0°) linear scan can be used, with the ultrasound focused at the interface between the pipe and EF fitting (Figure 2).

Since the heating wire coil is located above the fusion interface, sufficient resolution to be able to see both the wire and between the wire windings is required.

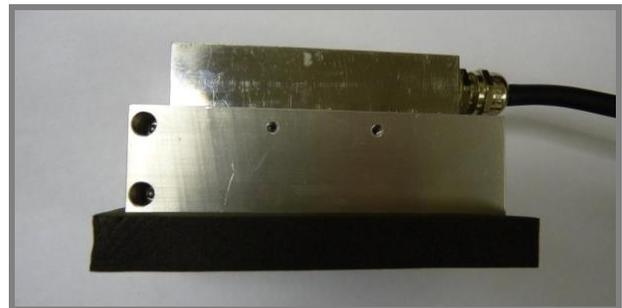
Figure 3. Zero degree water wedge/probe assembly used for inspecting small diameter EF joints.

In order to ensure good acoustic matching with the irregular surface of EF fittings and enable steering of the angled beam for BF inspection the probe wedges were open-faced water wedges, fitted with a flexible sealing skirt to keep the water in the wedge while it passes over the pipe or EF coupler. The angle of the wedges for inspecting the BF joints was optimized to minimize the electronic steering by the probe elements. Photographs of probe/wedge assemblies are shown in Figures 3 and 4.

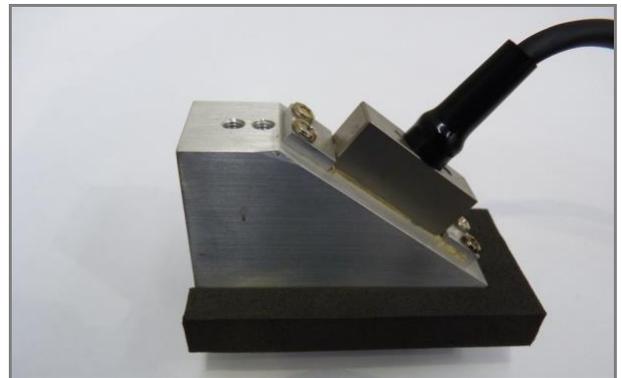
Figure 4. Angled water wedge/probe assembly used for inspecting small diameter BF joint.

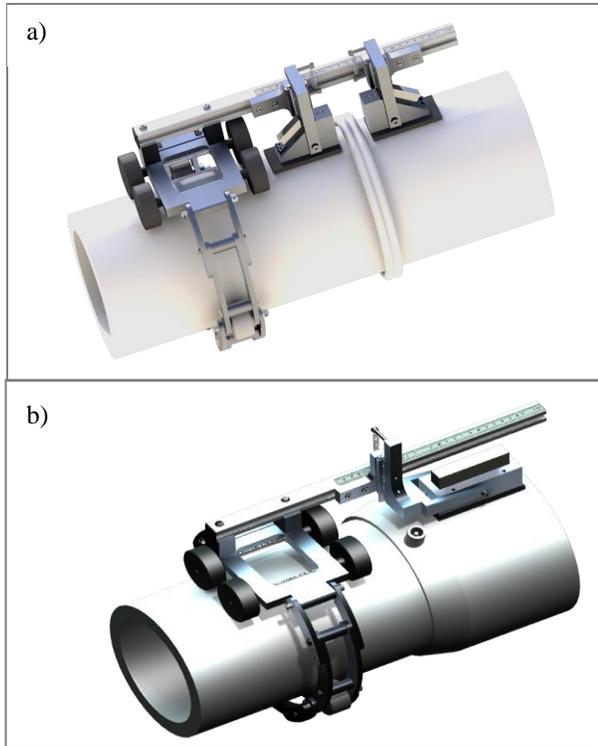
Figure 5. CAD design of the TestPEP inspection system without an encoder on the carriage for: a) BF joints, and b) EF joints.

Spring-mounted probe holders were designed to accommodate the different probe/wedge assemblies on

the same scanning system. The scanner consisted of a carriage, which contains an encoder to record the circumferential position around the joint and a support for the probe holders, and a series of chain links to hold the carriage on to the pipe (Figures 5 and 6).

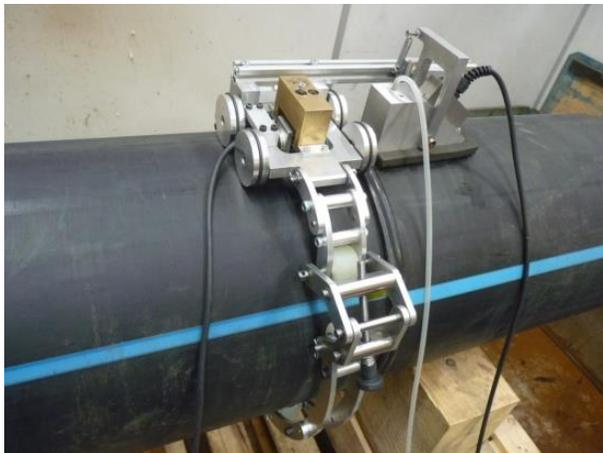
Figure 6. TestPEP inspection prototype system on a BF joint, with the encoder mounted on the carriage.

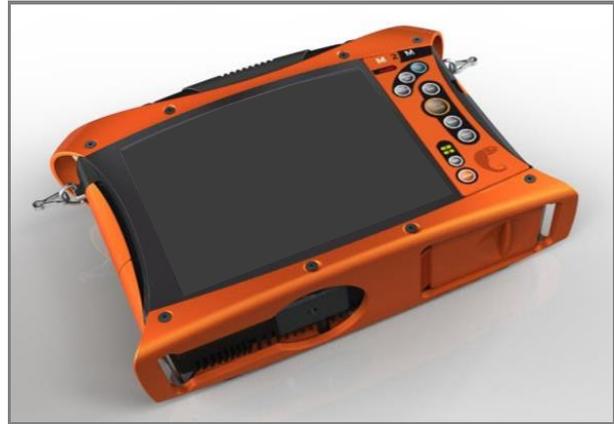
Figure 7. CAD design of TestPEP flaw detector.

As part of the TestPEP project a completely new flaw detector, with the ability to operate in harsh environments, was designed and manufactured (Figure 7), with the following features:

- Integrated ultrasonic hardware and PC board;
- Remote access to software application (ethernet or WiFi);
- IP67 protection for full immersion in water;
- 100 GB internal memory for data storage;
- Two rechargeable batteries allowing up to six hours continuous use.

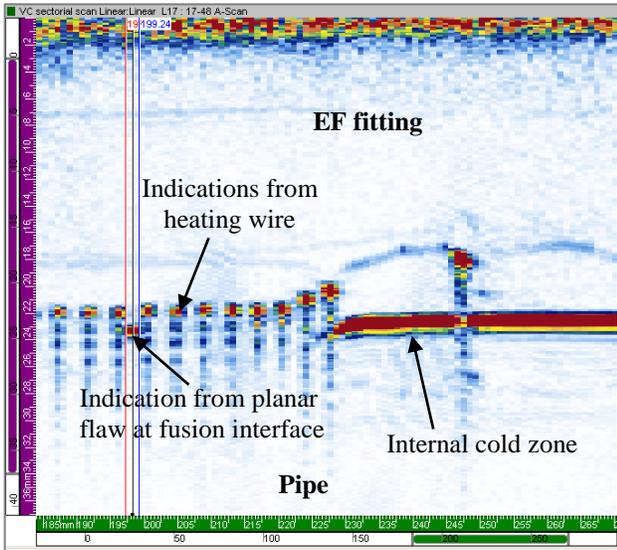
Figure 8. Ultrasonic image of a 225 mm (9 inch) SDR11 EF joint containing a 2 mm (0.08 inch) planar flaw at the fusion interface.

Figures 8 and 9 show ultrasonic images of a 225 mm (9 inch) SDR11 EF joint containing a 2 mm (0.08 inch) diameter planar flaw and where the pipe has not been fully inserted into the coupler, respectively. Both types of flaw can clearly be detected. Figures 10 and 11 show images from a standard 450 mm (18 inch) SDR17 EF joint and a cold fusion, where the heating time was reduced to 50% of the manufacturers recommended value, respectively. The line indication above the heating wires has been shown to be the boundary of the melt zone in the EF fitting [9]. The distance between the melt zone boundary indication and the indications from the heating wire can therefore be used to detect cold fusions [9,11, 12].

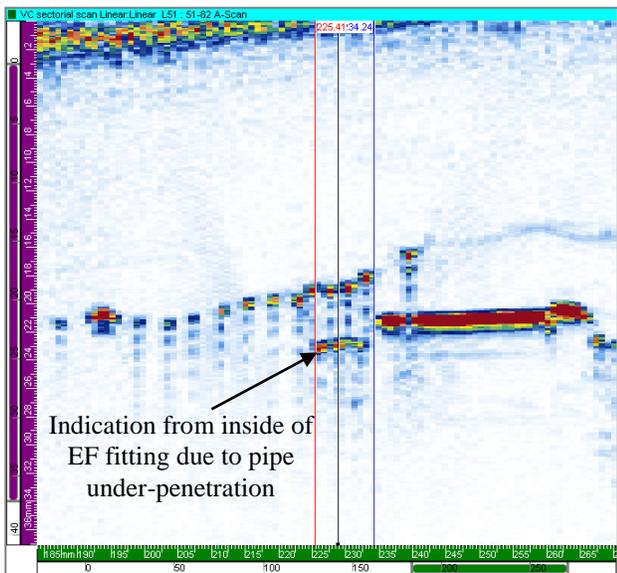
Figure 9. Ultrasonic image of a 225 mm (9 inch) SDR11 EF joint where the pipe has not been fully inserted into the coupler.

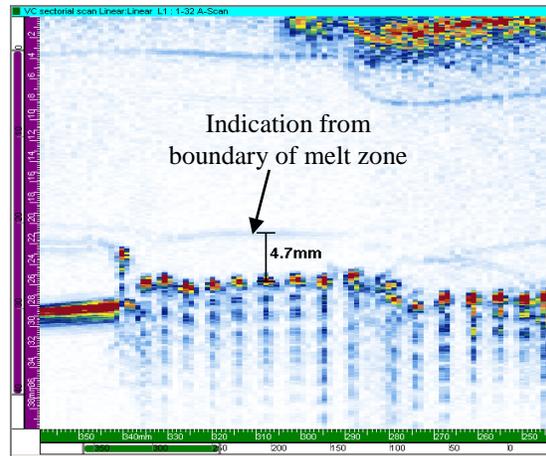
Figure 10. Ultrasonic image of a standard 450 mm (18 inch) SDR17 EF joint.

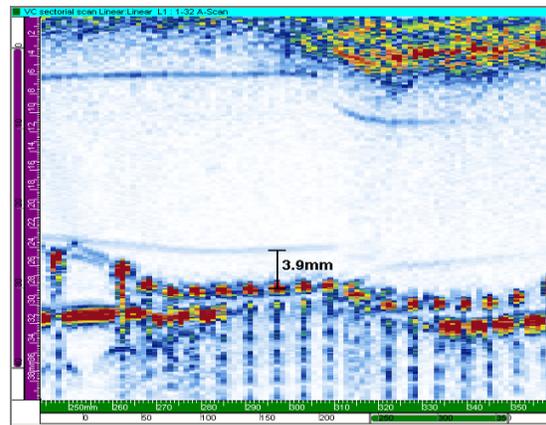
Figure 11. Ultrasonic image of a 450 mm (18 inch) SDR17 EF joint where the heating time has been reduced by 50%, resulting in a cold fusion.

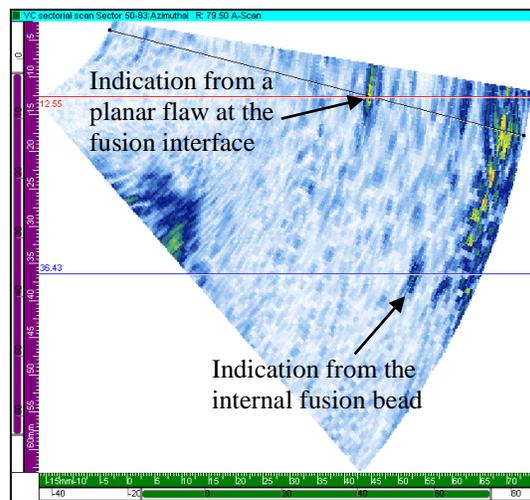
Figure 12. Ultrasonic image of a 355 mm (14 inch) SDR11 BF joint containing a 4 mm (0.16 inch) planar flaw at the fusion interface.

Figure 12 shows a sector pulse-echo image from a 355 mm (14 inch) SDR11 PE100 BF joint containing a 4 mm (0.16 inch) planar flaw at the fusion interface.

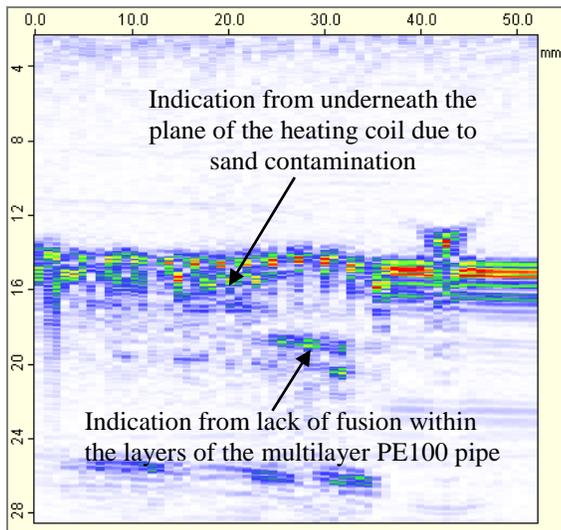
Figure 13. Ultrasonic image of an EF joint produced by E.ON Ruhrgas containing sand contamination.

E.ON Ruhrgas, Germany, manufactured nine EF joints in 110 mm (4.3 inch) SDR11 multilayer HexelOne® PE100 monocomposite pipes, some of which contained flaws and some which didn't. These joints were inspected blind in the laboratory and all nine joints were assessed correctly. For example, Figure 13 shows an ultrasonic image of a joint where the inspection suggested that it contained particulate contamination; E.ON Ruhrgas confirmed that sand had been inserted at the interface. It can also be seen in this image that there were indications from within the pipe wall, suggesting that the bond between the layers in the PE pipe was not perfect.

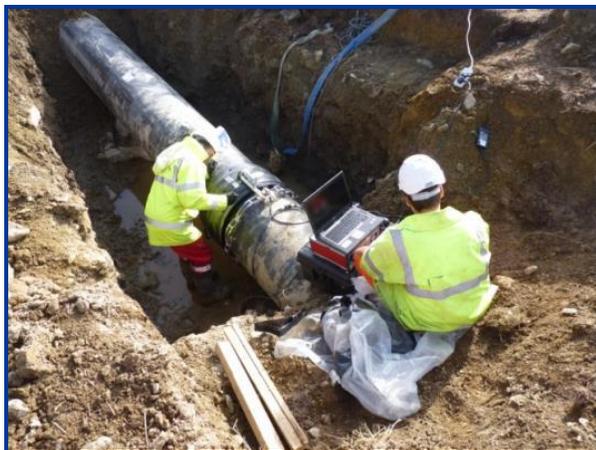
Figure 14. Inspection field trials in North Wales, UK.

Field trials were carried out in North Wales, UK, where EF joints in a 710 mm (28 inch) PE100 pipeline being installed for a hydro-electric power station were inspected (Figure 14).
