# Detection Capabilities of a Phased Array Ultrasonic Inspection System for Plastic Pipe Butt Fusion Joints

Fredrik Hagglund, Malcolm A Spicer and Mike J Troughton TWI Ltd Cambridge, CB21 6AL, UK Telephone +44(0)1223 899000 Telefax +44(0)1223 890952 E-mail fredrik.hagglund@twi.co.uk

#### **Abstract**

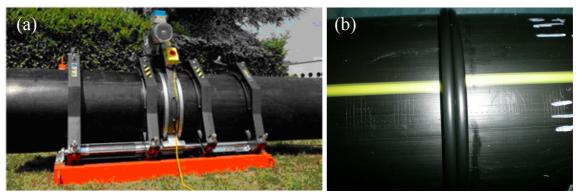
Figure 1. Butt Fusion pipe joint. (a) An onsite welding tool and (b) a completed weld with the outer surface weld bead.

The BF joint is created by using a heating plate to melt the ends of two pipes which are then fused together by a pressure applied for a certain time (Figure 1(a)). The process then creates a weld bead of the excess pipe material on both the inner and outer surface (Figure 1(b)).

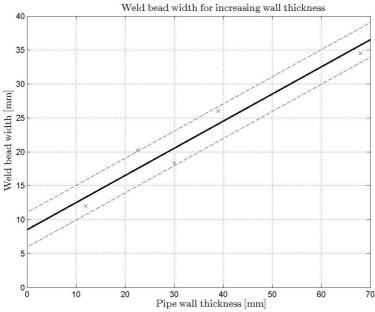
Figure 2. Average weld bead versus the pipe wall thickness. The distance between the front of the probe wedge and the weld centreline needs to be greater than half the weld bead width.

A severely bad weld can be identified by visual inspection of the external weld bead. However, the weld bead can be intact without deformations and the weld can still contain flaws. In some industries and countries, the weld bead is removed after the welding cycle is completed. However, in some instances, especially in the utilities industry, the weld bead is kept intact. The techniques developed in this study are aimed at the inspection of BF joints with the weld bead intact, which will have some practical implications on the developed inspection techniques and the probe and wedge selections, especially since the weld bead width will vary depending on pipe geometry and welding procedures (Figure 2).

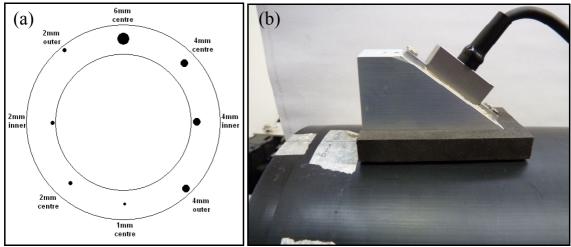
Figure 3. (a) Arrangement of FBHs in the pipe end. (b) Probe position inspecting the pipe with the FBHs.

When developing the inspection techniques for BF joints, test samples with artificial flaws were used, covering a range of pipe sizes between 220mm and 450mm OD. Flat bottom holes (FBHs) were considered sufficient to evaluate the performance of the proposed techniques. The FBHs were used to evaluate the tandem and the sector pulse-echo techniques and they were machined at the pipe ends. The arrangement of the FBHs for the 220mm OD pipe are shown in Figure 3(a) and the FBHs inserted in all pipes are given in Table 1. In Figure 3(b) the probe position when inspecting the FBHs on the 220mm OD pipe is shown. The FBHs are 40mm deep from the pipe end and the probe is positioned 47mm from the pipe edge leaving the extra 7mm to simulate half of the weld bead.

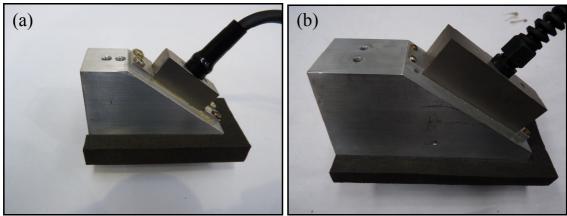
Figure 4. Angled water probe wedge. (a) 4MHz and (b) 2MHz.

To perform the inspection on plastic pipes, novel open face water wedge prototypes have been designed and manufactured. The advantages of using a water wedge are low attenuation and a velocity ratio enabling the steering of angled beams to the fusion zone. High angles are required since the weld bead prevents optimal positioning of the probes. The wedges with the probes are shown in Figure 4, the 4MHz probe is shown in (a) and the 2MHz probe is shown in (b). The figure also shows the flexible sealing skirt that is used to effectively keep the water in the probe wedge.

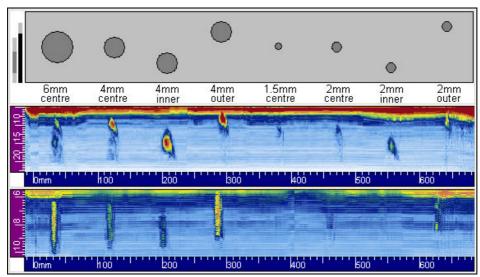
Figure 6. Schematic drawing of the cross-section of the 220mm OD and 14mm thick pipe with FBHs and the sector pulse-echo and tandem inspection results.

In Figure 6 the inspection results for a 220mm OD, 14mm thick PE100 pipe are presented. In the top image a schematic drawing of the cross-section of the pipe with FBHs is shown. The inspection result from the sector pulse-echo technique shows that the technique detected all the FBHs. With the tandem technique six out of the eight FBHs are detected.

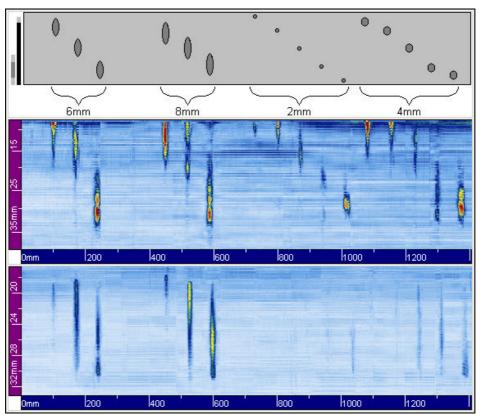
Figure 7. Schematic drawing of the cross-section of the 450mm OD and 28mm thick pipe with FBHs and the sector pulse-echo and tandem inspection results.

In Figure 7 the inspection results for a 450mm OD, 28mm thick PE100 pipe are given. The sector pulse-echo technique managed to detect all the FBHs, while the tandem technique reliably detected ten out of the 16 FBHs. Weak indications are shown from some of the other FBHs. The undetected FBHs are the ones closest to the outer surface.

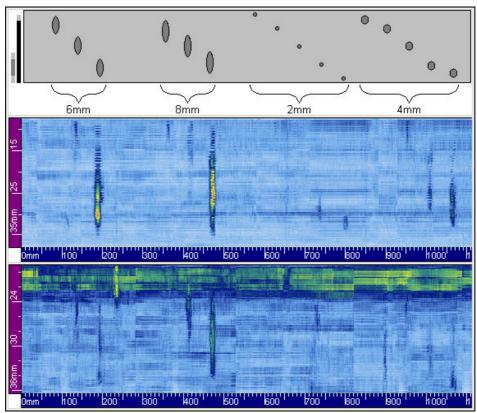
Figure 8. Schematic drawing of the cross-section of the 355mm OD and 33mm thick pipe with FBHs and the sector pulse-echo and tandem inspection results.

In Figure 8 the inspection results for a 355mm OD, 33mm thick PE80 pipe are presented. The sector pulse-echo technique managed to detect ten of the 16 FBHs, while the tandem technique reliably detected eight out of the 16 FBHs. Some weak indications are shown from some of the other FBHs and the undetected FBHs are again the ones closest to the outer surface.
